APPLICATION NOTE

FAST Thermal Imaging: The New Way to Look at Ballistic Impacts

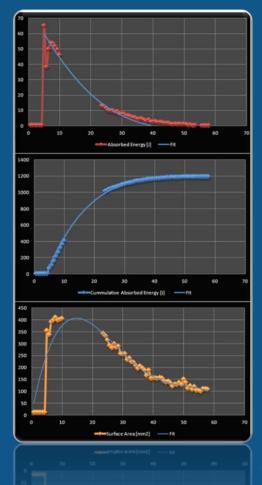
Figure 7: Ballistic impact - Absorbed energy (top), cummulative energy (middle), and surface area affected by the impact (bottom).

Another interesting way to analyze the performance of the FAST-IR 1000 infrared camera in this high dynamic and high energy application is to look at the dynamic progression of the energy over the entire images and surface area affected by the ballistic impact. As shown in Figure 7, the user has direct access to the total absorbed energy occurring during the impact. In fact, the total energy absorbed peaks around 1193 Joules after approximately 60 ms. More than 40% of the total energy absorbed by the ballistic material occurred within the first (1) ms following the impact. Considering that the ballistic kinematic energy [1/2 mv²] of the bullets before the impact is about 1679 Joules, it was calculated that more than 71% of the bullet kinematic energy has been absorbed by the wooden laminate. Moreover, the total affected surface area is approximately 400 mm². The ratio between the absorbed energy and the total surface area indicates the maximum energy density never exceeded 0.2 Joules/mm².
